TWR-17543 Vol. III

FLIGHT SET 360T004 (STS-30)  
INSULATION COMPONENT FINAL REPORT  
VOLUME III  
INTERIM RELEASE

27 June 1989

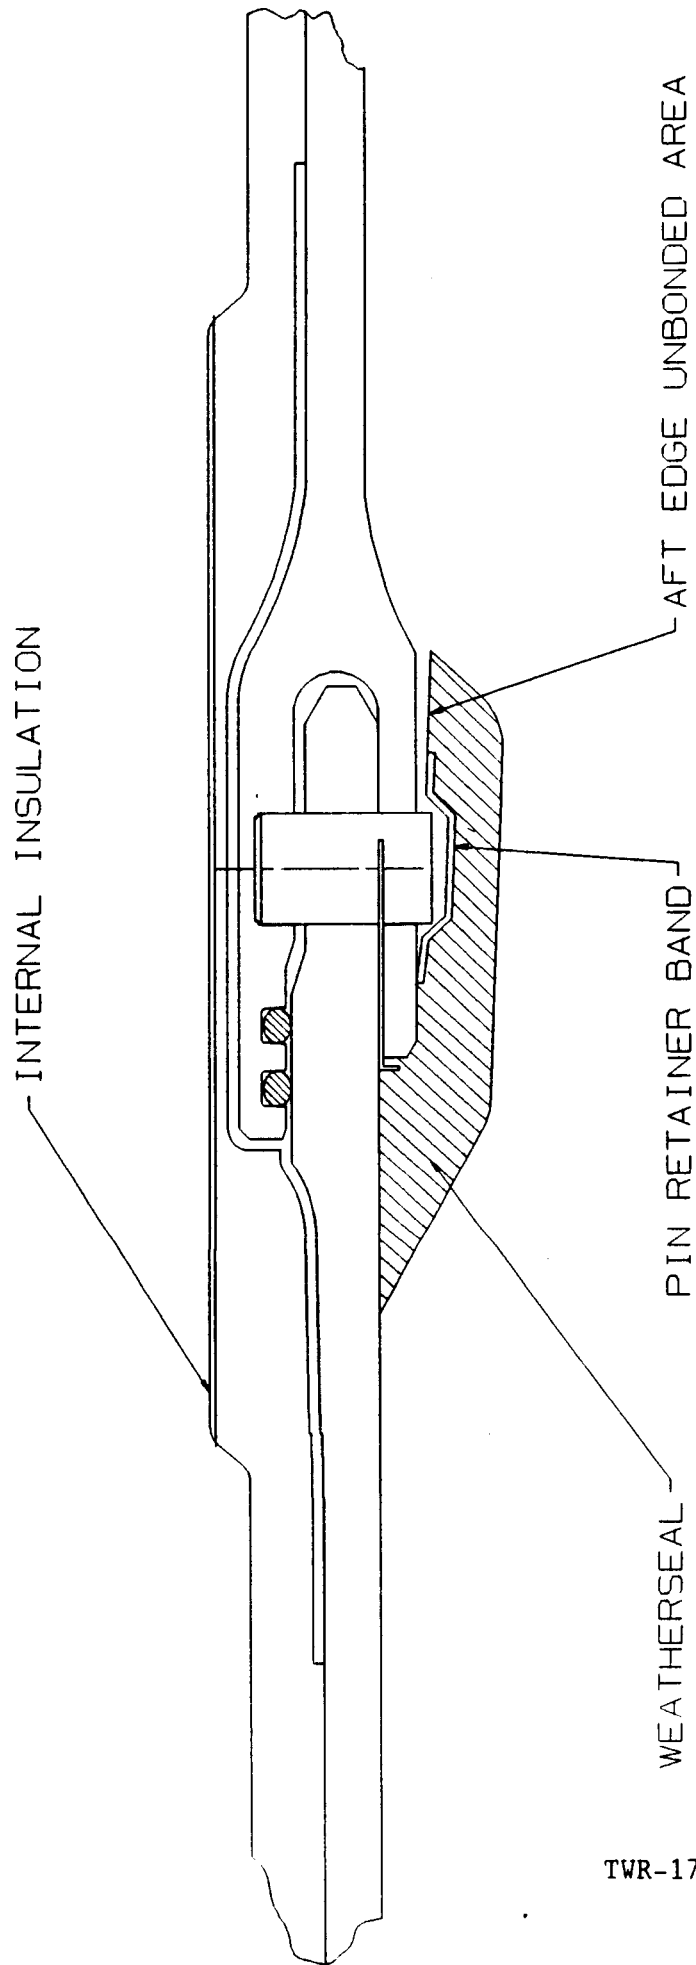
The largest unbond extended 35.0 inches circumferentially. The pin retainer band was displaced, leaving the pins visible under some of the unbonded areas. The total unbond area covered approximately 31 percent of the circumference on the aft edge. One similar unbond was present on the aft dome factory joint weatherseal aft edge near 278°. This unbonded area measured 3.75 inches circumferentially and extended axially to the pin retainer band. An aft edge unbond was also found on the forward center segment factory joint weatherseal near 28°. This unbond was smaller, measuring 1.2 inches circumferentially and only extending 0.40 inch axially, not to the pin retainer band. All of the unbonds exhibited adhesive failure at the Chemlok 205 to case interface. Light rust contamination existed on the case underneath the unbonds. No evidence on sooting or heat effects were present under the unbonded areas.

After evaluating the case surface finish at the weatherseal bonding area for RSRM-3 through RSRM-7, it has been determined that the surface finish for the aft edge of the RSRM-4A aft segment factory joints were among the smoothest in the database of the the joints surveyed. Smooth surface finish constitutes a strong cause for bondline failure.

The unbonds are believed to have occurred at splashdown since no sooting or heat effects were present underneath the unbonded regions. Splashdown/cavity collapse represents the highest loading induced on the bondline and is a probable explanation for multiple separate unbonds. The extent of corrosion was also consistent with the exposure duration which would occur at splashdown and was not consistent with extended exposure to the elements. This was evidenced by comparison with the dissection at KSC of RSRM-2 weatherseals which experienced water intrusion.

FIGURE 2  
RSRM-4A AFT SEGMENT STIFFENER TO STIFFENER  
FACTORY JOINT WEATHERSEAL UNBONDS

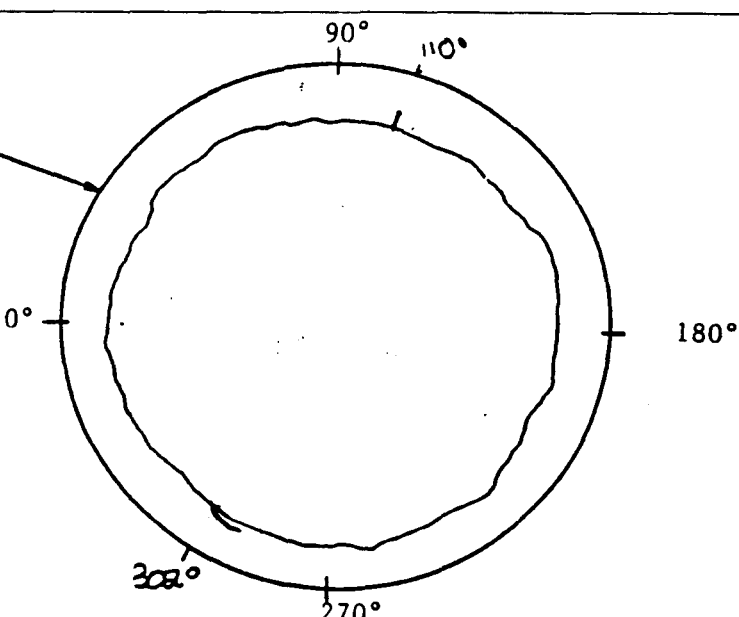
There was one circumferential inhibitor tear greater than 3 inches in length. The tear extended 3.2 inches circumferentially. One radial tear over 3.0 inches existed at 110°. It was located 4.5 inches inboard of the clevis I.D. surface and was 3.1 inches long. The edges of both of these tears showed no signs of charring or erosion indicating the tears occurred after motor burn. The tear is documented in Table A-21.

Degree Location	Meas. "A"	Meas. "B"	Comments (Charring, etc.)
110°	4.5 in.	3.1 in.	No Charring

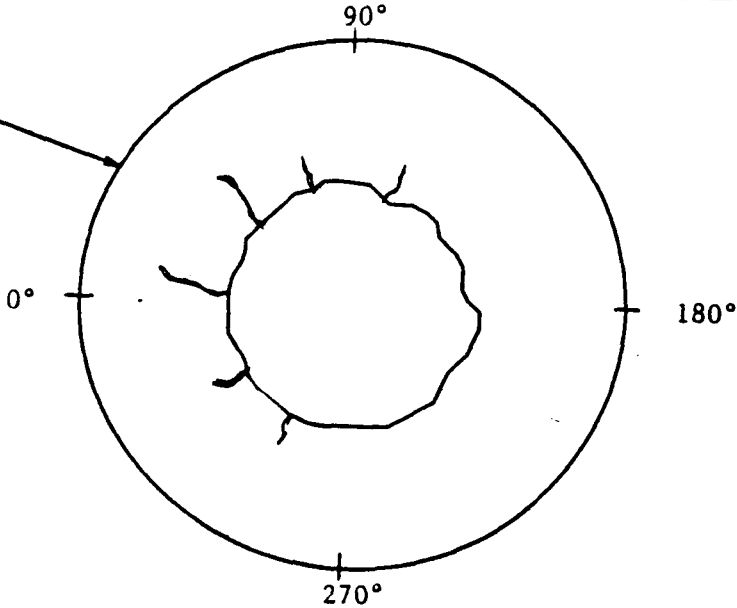
Six radial tears greater than 3 inches long were noted. The longest tear was 11.8 inches and extended radially outward to approximately 10.2 inches inboard of the clevis I.D. surface. The edges of the tears demonstrated no material loss or erosion. This indicated that the tears occurred after motor burn. The location and length of the tears are contained in Table A-28. The tears are believed to be a result of re-entry or splashdown loads.

Degree Location	Meas. "A"	Meas. "B"	Comments (Charring, etc.)
4	14.0 in.	8.6 in.	No Charring
50	17.7 in.	5.8 in.	" "
82	11.9 in.	11.7 in.	" "
108	10.2 in.	11.8 in.	" "
286	17.2 in.	7.5 in.	" "
324	20.5 in.	5.5 in.	" "

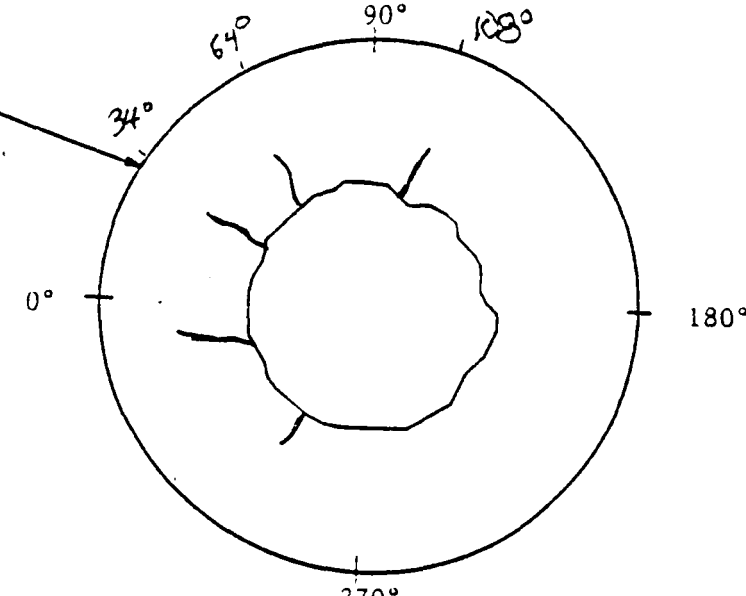
Degree Location	Meas. "A"	Meas. "B"	Comments (Charring, etc.)
34	14.5 in.	11.0 in.	No Charring
64	12.7 in.	13.0 in.	" "
108	10.0 in.	14.4 in.	" "
330	15.5 in.	10.0 in.	" "
358	18.0 in.	7.9 in.	" "
